Manhole Inspection Summary

Manhole # S25E__013MH

Insp Date: **4/7/09 1:13 PM**

Location Address: **1001 CARLTON ST**

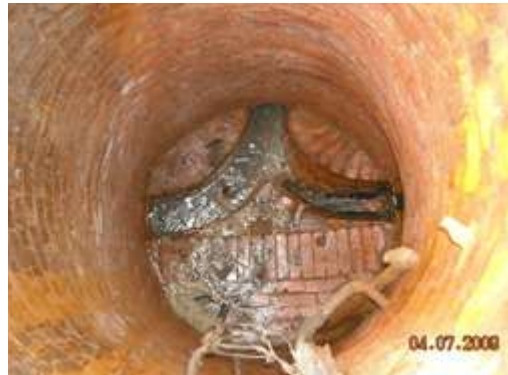
Top View

Comments **LID CUT OPEN BY SAW ON 4/3/09 REPLACED WITH NEW 24" SANITARY LID. 1/2 HOUR OF SPECIALTY CLEANING REQUIRED TO RESTORE FLOW IN MANHOLE. INSPECTION COMPLETE.**
